DOCKSIDE TM

MARINE EQUIPMENT AND SERVICES

JANUARY, 1996 VOL. II, NO.1

Planking From An Owner's Point of View

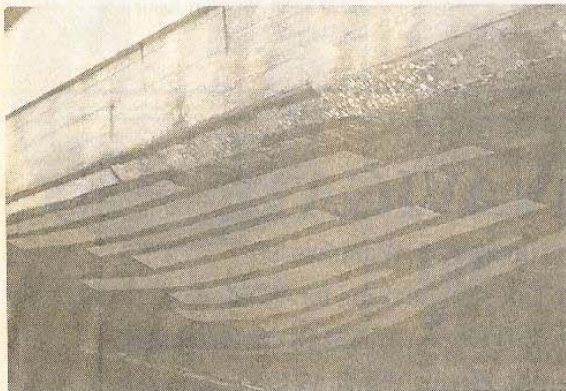
An example of a built-in structural weakness: short planks with numerous clustered butts and a stair-step pattern.

tened directly to the frames. Avoid diagonal (stair-step) butt alignment and butts clustered together. The proper choice of timber can be a long-winded conversation. Boat lumber is air dried instead of kiln dried. The cut, and direction of the grain is very important to consider in selecting your plank stock. Carefully plan your project. We will continue with this subject next month. Send in your questions and thoughts. Cheers!

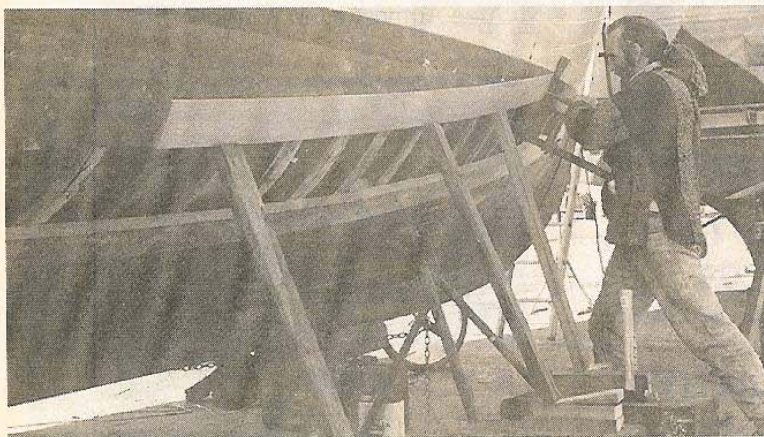
The success of a plank repair is dependent on good planning and good materials.
